Flexible Pavement Assessment of Selected Highways in Orolu Local Government South - Western Nigeria

Original Research Article

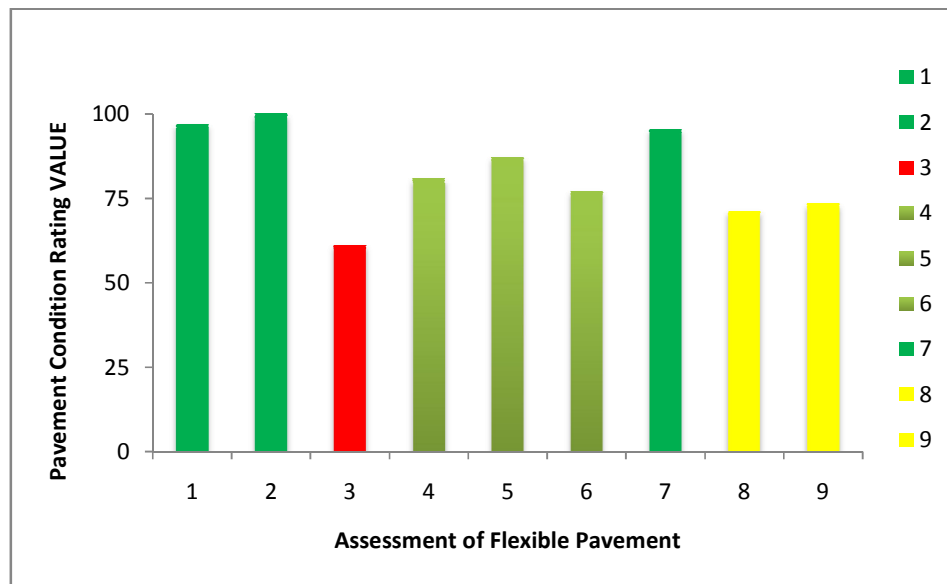
Fig. 3.1. Bar chart representing the PCR of the roads

The method of survey employed is the Pavement Condition Rating (PCR). A total of nine roads were surveyed with route numbers indicated in the Table 3.1 below. According to the PCR rating scale it was observed that only three roads AFP1, AFP2 and AFP7 were in very good condition, while AFP4, AFP5 and AFP6 can be regarded as good, AFP8 and AFP9 falls in the category of fair and only AFP3 sits in the class of fair to poor. During this survey, it was also observed that AFP3, AFP6 and AFP9 do not conform with the standard width of 7.30 m (3.65 m x 2) for two lane highway sections and road furniture such as shoulder, walkway and median were invariably absent in all roads as specified [6].

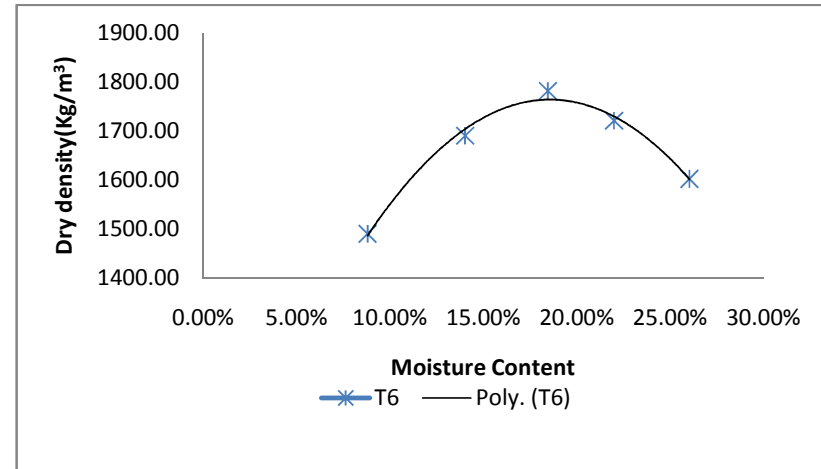
Fig. 3.4. Compaction curve of sample T1

Fig. 3.5. Compaction curve of sample T2

Fig. 3.6. Compaction curve of sample T3

Fig. 3.7. Compaction curve of sample T4

Fig. 3.8. Compaction curve of sample T5

Fig. 3.9. Compaction curve of sample T6

Fig. 3.10. Compaction curve of sample T7

Fig. 3.11. Compaction curve of sample T8

Fig. 3.12. Compaction curve of sample T9

Fig. 3.13. Compaction curve of sample T10

West African standard was used. The maximum dry density (MDD) ranges between 1730.02 kg/m³ and 1960 kg/m³, which is typical for materials within the range of silty clay to sandy clay, while the optimum moisture content (OMC) ranges between 13.05% and 20.0% as indicated in table. Figs 3.4 – 3.13 shown values of MDD against OMC Sample T4 has the highest optimum moisture content and lowest maximum dry density.

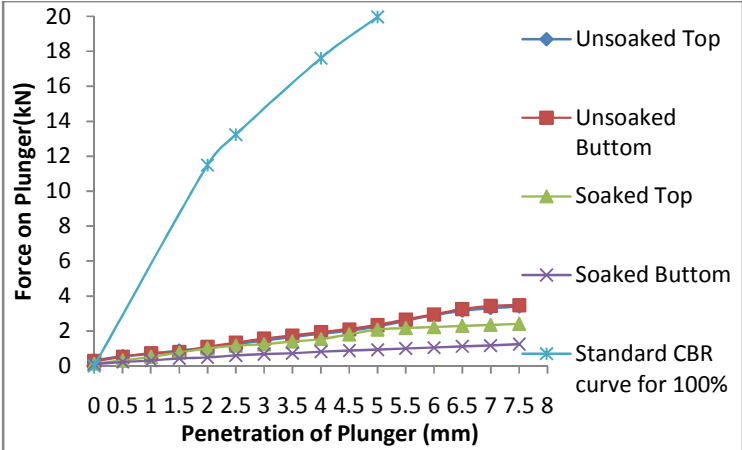
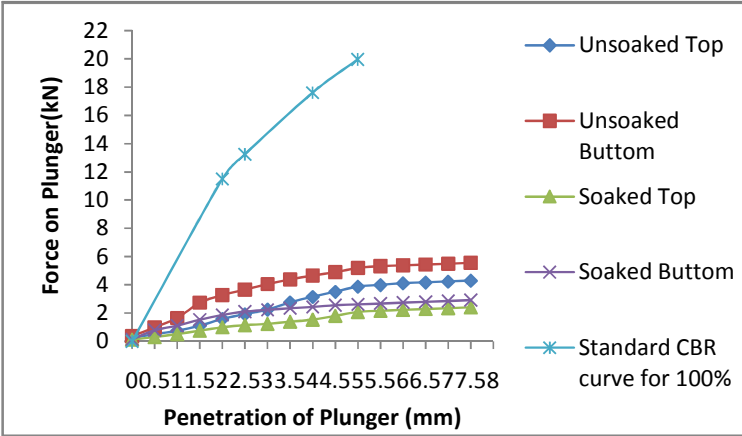
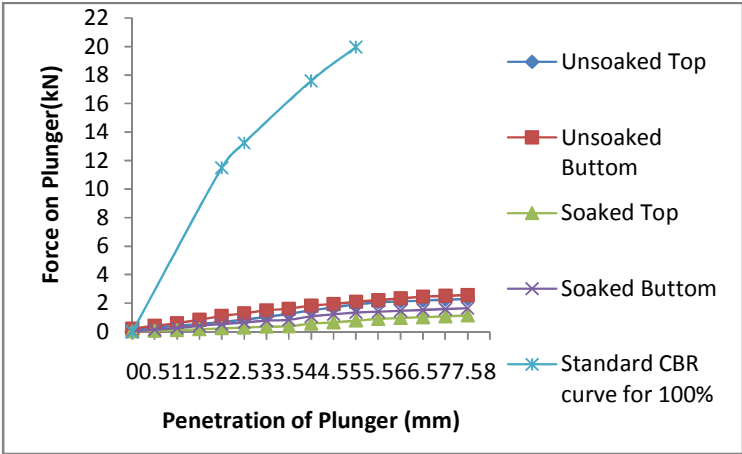
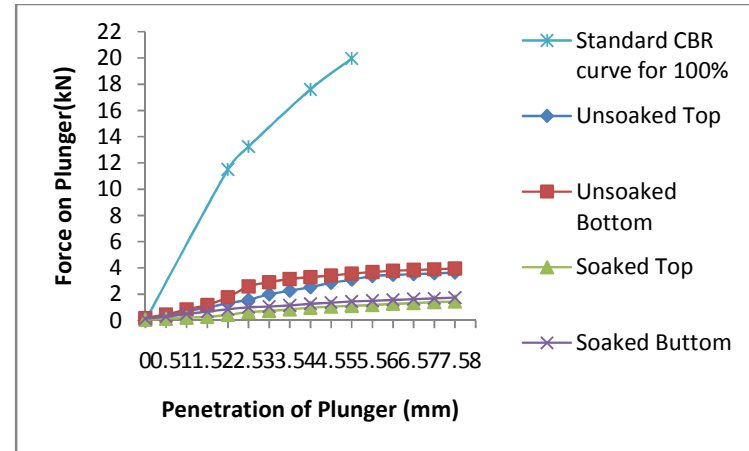
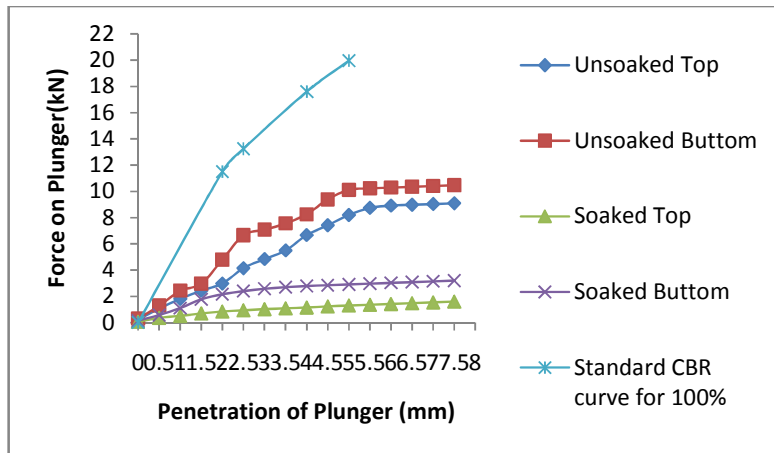
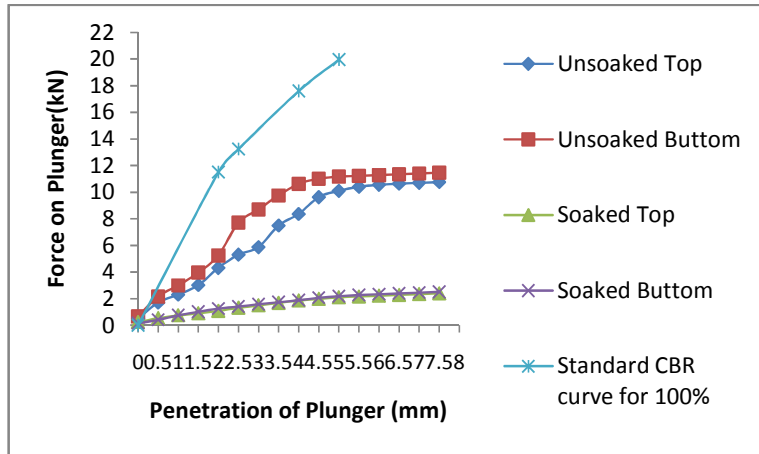
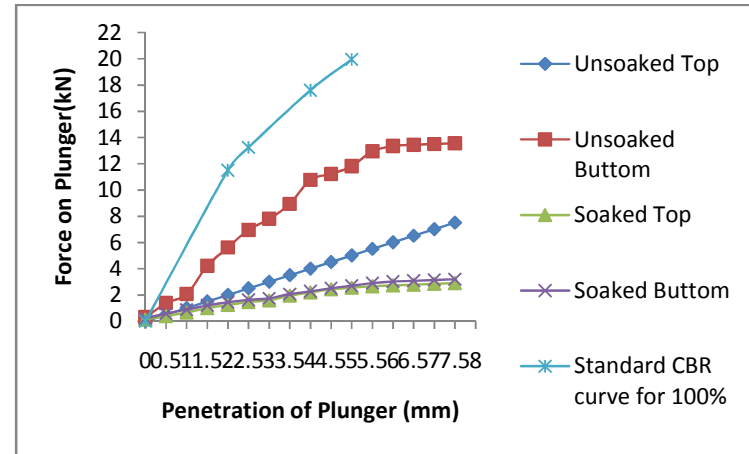
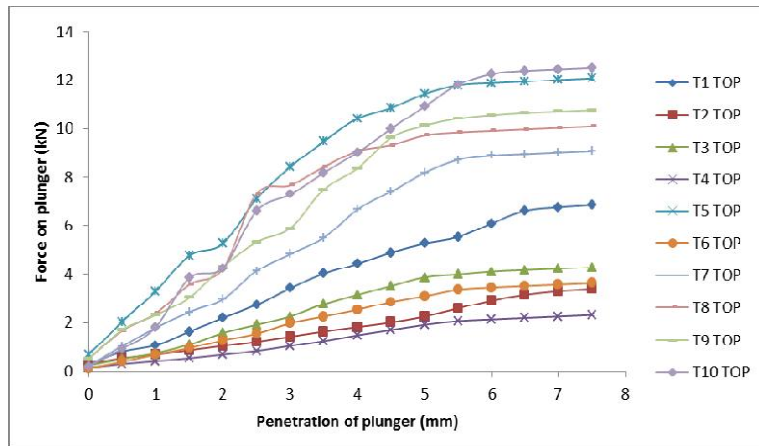
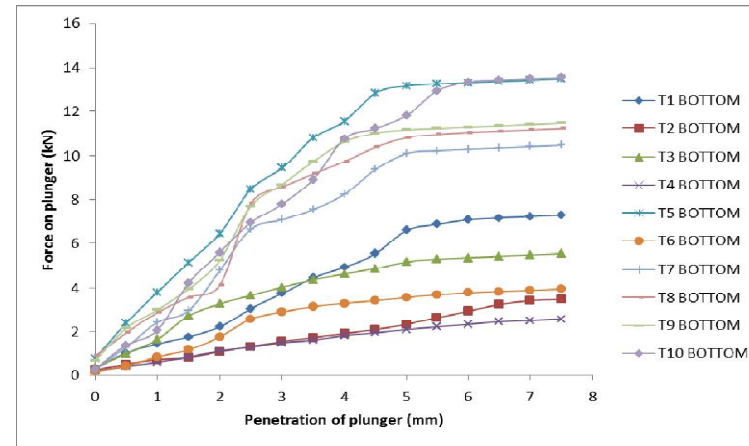
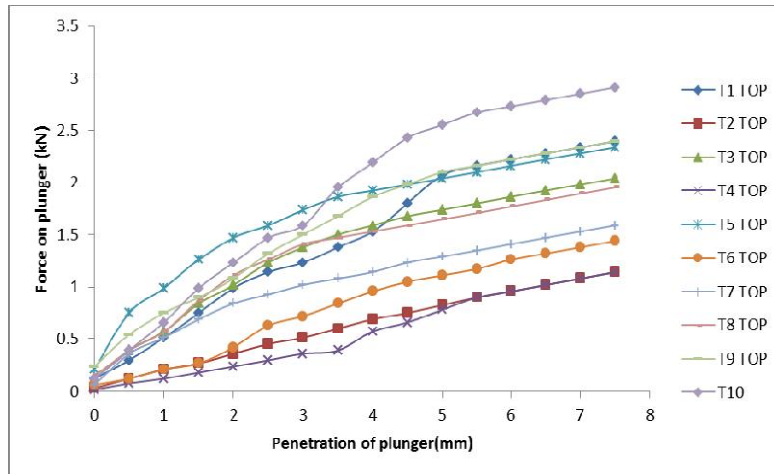
Fig. 3.14. CBR curve of sample T1

Fig. 3.15. CBR curve of sample T2

Fig. 3.16. CBR curve of sample T3

Fig. 3.17. CBR curve of sample T4

Fig. 3.18. CBR curve of sample T5

Fig. 3.19. CBR curve of sample T6

Fig. 3.20. CBR curve of sample T7

Fig. 3.21. CBR curve of sample T8

Fig. 3.22. CBR curve of sample T9

Fig. 3.23. CBR curve of sample T10

Fig. 3.24. California bearing ratio of unsoaked soil samples (Top)

Fig. 3.25. California bearing ratio of unsoaked soil samples (Bottom)

Fig. 3.26. California bearing ratio of soaked soil samples (Top)

Fig. 3.27. California bearing ratio of soaked soil samples (Bottom)

The CBR values for the un-soaked soil samples ranges from 10.13% to 65.07% while the values for soaked samples falls within the range of 4.60% and 20.69% as shown in Figs. 3.14 – 3.27. The notable decrease in CBR value

between the un-soaked and soaked samples implies that the resistance to penetration decreases drastically after the soaking. It was recommended that for soaked samples the values of CBR for subgrade, subbase and road base should not be less than 10%, 30% and 80% respectively [7,12-15]. This implies that samples T2, T4 and T6 are not suitable as subgrade material and could have contributed to the failure of the pavement at the section, also one can infer that none of the samples tested qualifies to be either subbase or base material and if otherwise used might pose a threat to the pavement in Orolu Local Government.

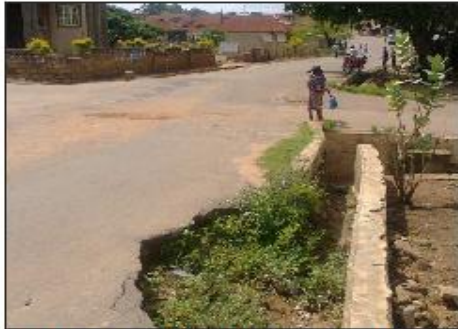
Plate 1 Showing the presence of edge crack with high severity (Kelebe Road)

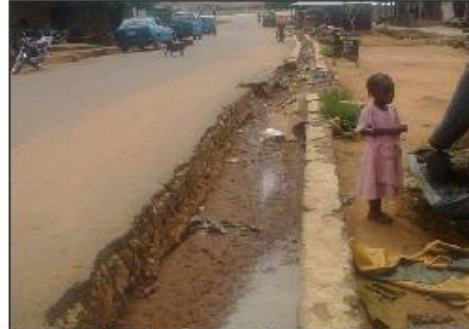
Plate 2 Showing the presence of edge crack defect with high frequency thereby leading to the collapse of the drain wall. (Kelebe Road).

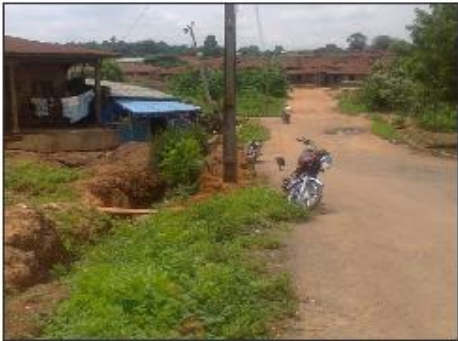
Plate 3 Showing the growth of shrubs on the pavement (Olode Road)

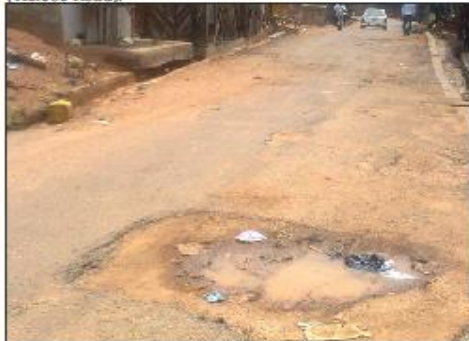
Plate 4 Showing pothole with medium severity (Olode road)

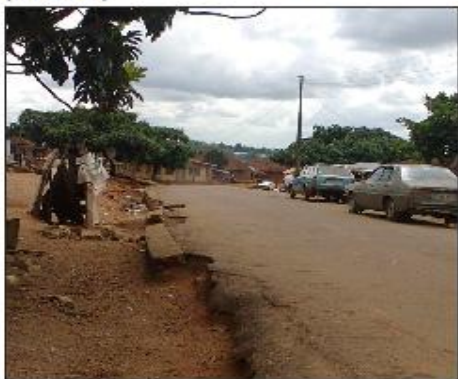
Plate 5 Showing the presence of edge crack defect and the absence of line drain (Elder Akande road).

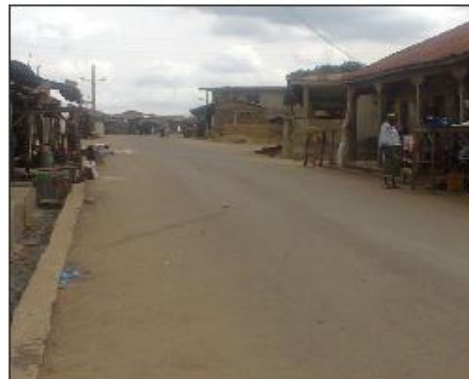
Plate 6 Showing a good section of a pavement with adequate drainage facility (Jamodo - Central Mosque road).
