# **Inventory of Active Landslides and Landslide Hazard Assessment Using Field Techniques and Remotely Sensed Data: A Case Study from Balkhila Sub-Watershed (Uttarakhand, Himalaya)**

**Case Study**

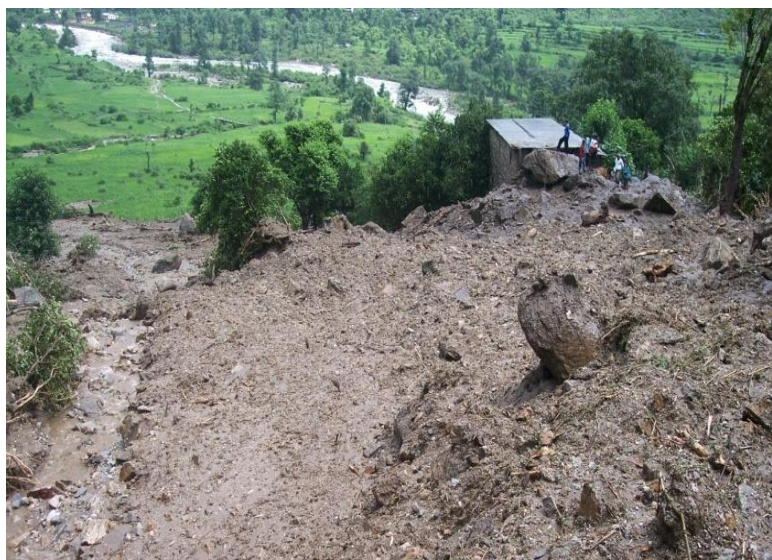
Plate 1. Impact of Bandwara landslide (August 2007) on agriculture and settlement

The Balkhila Watershed of Chamoli District in Uttarakhand, Himalayas has high landslide hazard and creates a major disaster in the area every year. However, the available information on the landslides in the Balkhila region is still limited. Gangolgaon-Ghingran cloudburst event (August, 1991), Bandwara landslide (August, 2007) (Plate1) and Siron landslide (July, 2017) are some of the burning examples that have caused large-scale human tragedies, material damage and associated environmental and social hazards in this region.

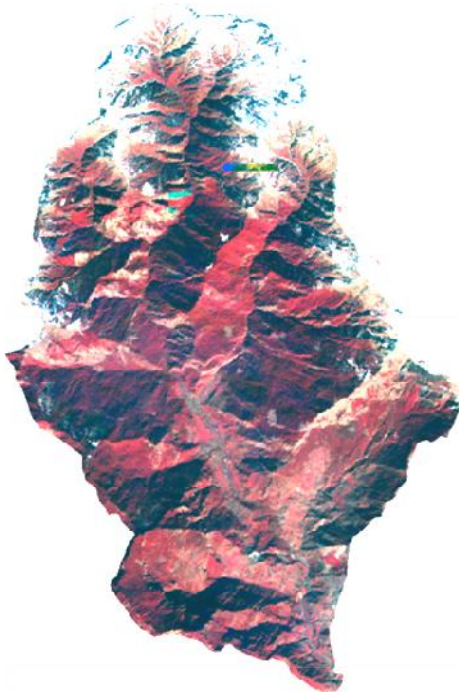
Fig. 2. Satellite imagery (LISS III) of the study area

Visual interpretation of the LISS III data (Fig. 2) and extensive field check of the landslides throughout the area has been carried out with the help of Global Positioning System (GPS) for identification and mapping of active landslides. Out of 52 landslides identified on the satellite data, only 26 prominent and accessible landslides were taken under consideration for detailed inventory (Fig. 3).

The LISS III satellite imagery is composed of blue, green, red, and near-infrared wavebands. The landslide has a stronger reflectance than other land covers in the green and red wave bands. However, in the near-infrared wave band, vegetation reflects the near-infrared more strongly than bare soil (landslide). It has been found that LISS III data is quite useful for terrain feature extraction, analysis and synthesis. Active Landslide distribution map and inventory of landslides are quite useful for assessing the hazard associated with landslides in the region.
